**Mandatory Service Bulletin for
Cessna 208 / 208B Modified with the Installation of
Survey Tail Boom Assembly and Tail Video Camera (Access Panels).
CESSNA 208 AND 208B RUDDER BELL CRANK FOULING CONDITION**

Date: August 17, 2012.

MSB-LCAS-001 R-0

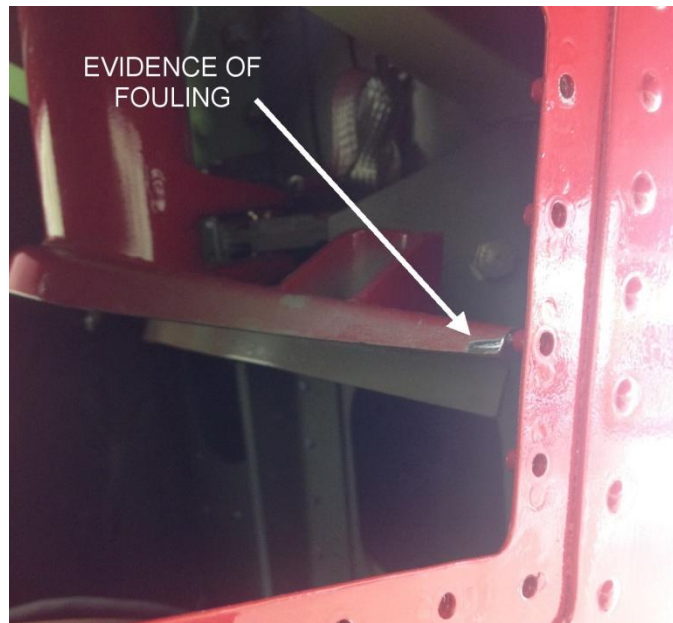
It has been determined that the rudder bell crank on some modified airplanes may foul against the mounting hardware (screws and / or anchor nuts) which secure the left hand and / or the right hand video camera access panels.

The left and right hand side video camera access panels shall be removed and the interior of the tail boom transition cone shall be inspected for fouling conditions resulting from contact between the rudder bell crank and the video camera access panel mounting hardware. Non-compliance with this mandatory Service Bulletin could result in the premature wear and / or failure of the previously mentioned components. See picture below for evidence of the potential condition.

1. Remove video camera access panels (PN LCA00306-004).
2. Inspect the AN526C-832R8 screws for evidence of wear as a result of slight contact or an existing fouling condition. If evidence of contact is found; replace all of the AN526C-832R8 screws with AN526C-832R6 screws.
3. If the rudder bell crank is capable of contacting any of the MS21070-08 anchor nuts (after installation of the shorter AN526C-832R6 screws), or is closer than 1/8 inch; remove the offending anchor nut and remanufacture the video camera access panel from .063" 2024 T3 aluminum, being certain to eliminate the screw hole that corresponds to the removed anchor nut.

1. If contact was found and remedied by switching to the shorter AN526C-832R6 screws, fix a placard to the access panels that states "SECURE ACCESS PANEL WITH AN526C-832R6 SCREWS".
2. If contact was found and remedied by removal of an existing MS21070-08 anchor nut and remanufacturing the access panel from .063" 2024 T3 aluminum; placard the access panel(s) with appropriate alignment marks to ensure correct placement when secured to the aircraft.
